# OR Annual report 2021

### Sewage treatment, overflows and sea water quality

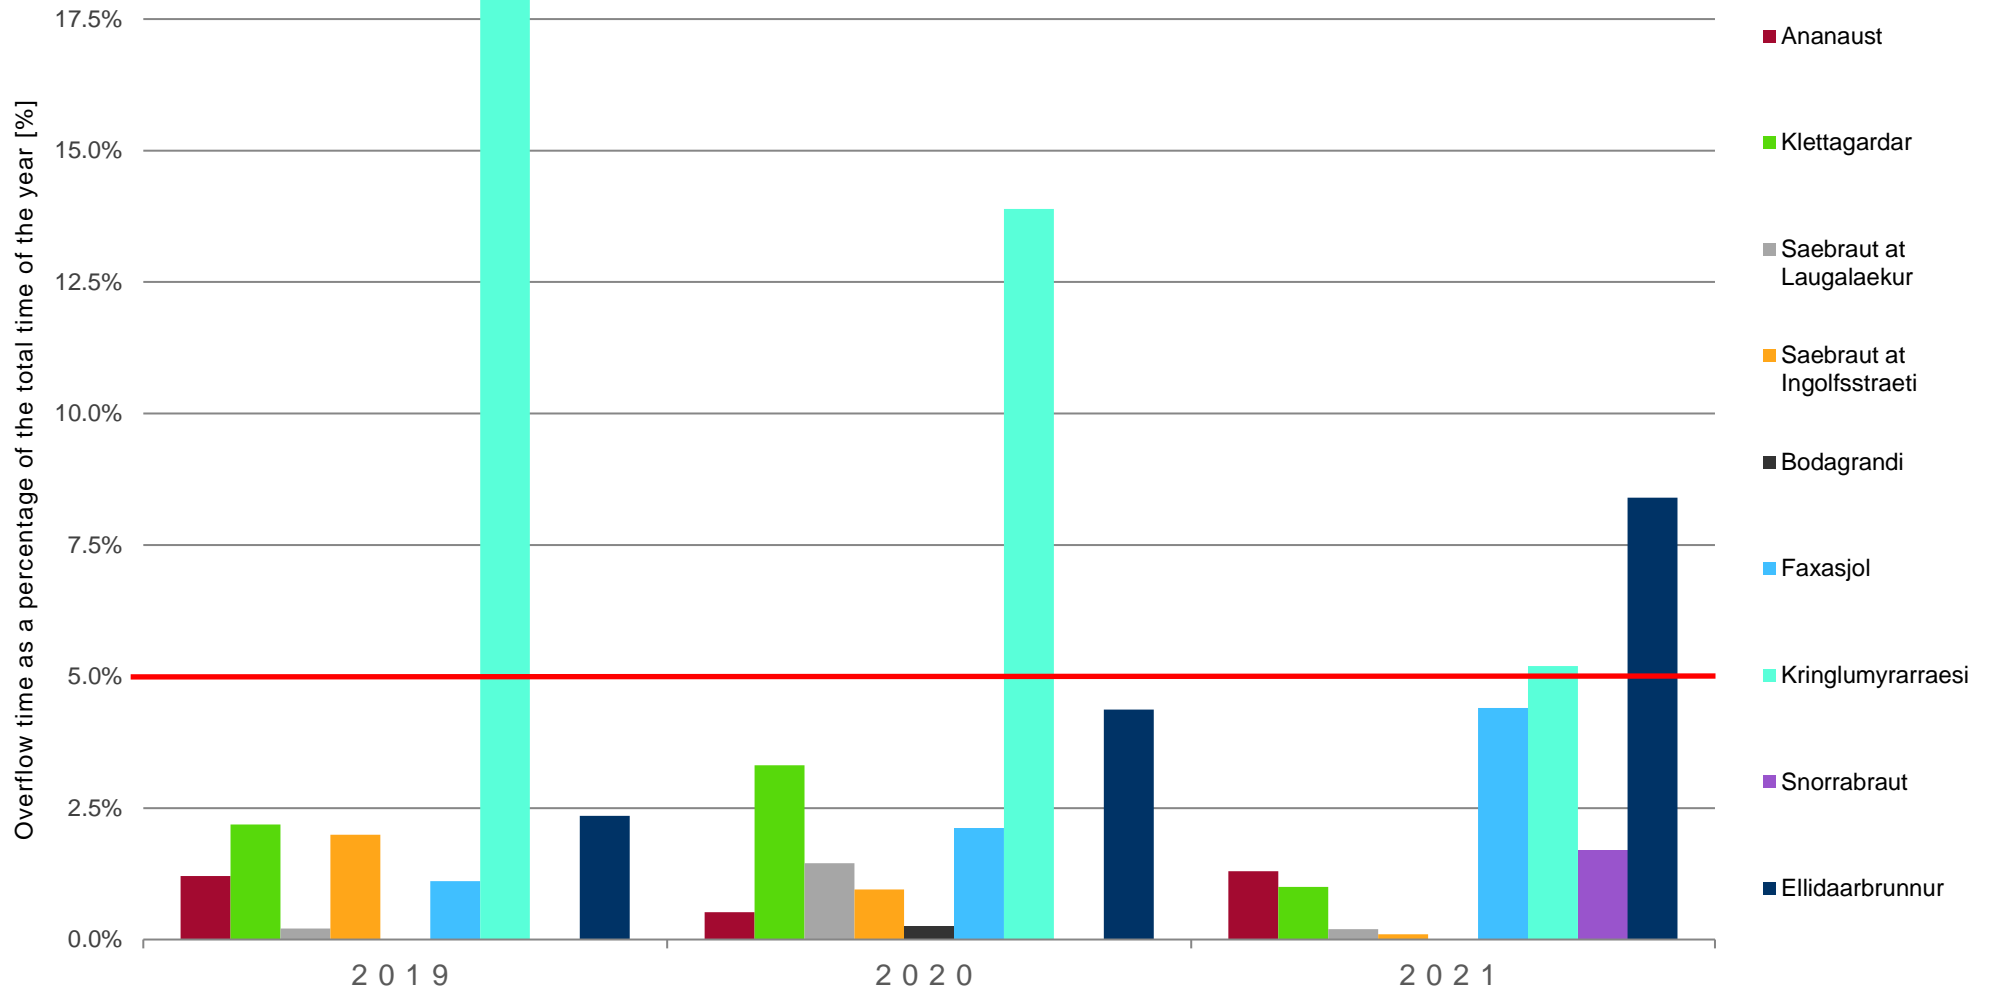
## Release via overflows in Reykjavik 2018-2021

Major maintenance in October and November 2021 at the Klettagardar sewage treatment plant caused emergency overflows to be active for 730 hours during the year. Emergency overflows at Faxaskjol, Klettagardar and Ingolfsstraeti were inactive throughout the year

According to regulation no. 798/1999 on Sewerage systems and Sewage, overflow in the sewerage system may be active for up to 5% of the time of the year, or when the sewage mixed with hot water from district heating utilities or rainwater is at least on a ratio of 1:5.

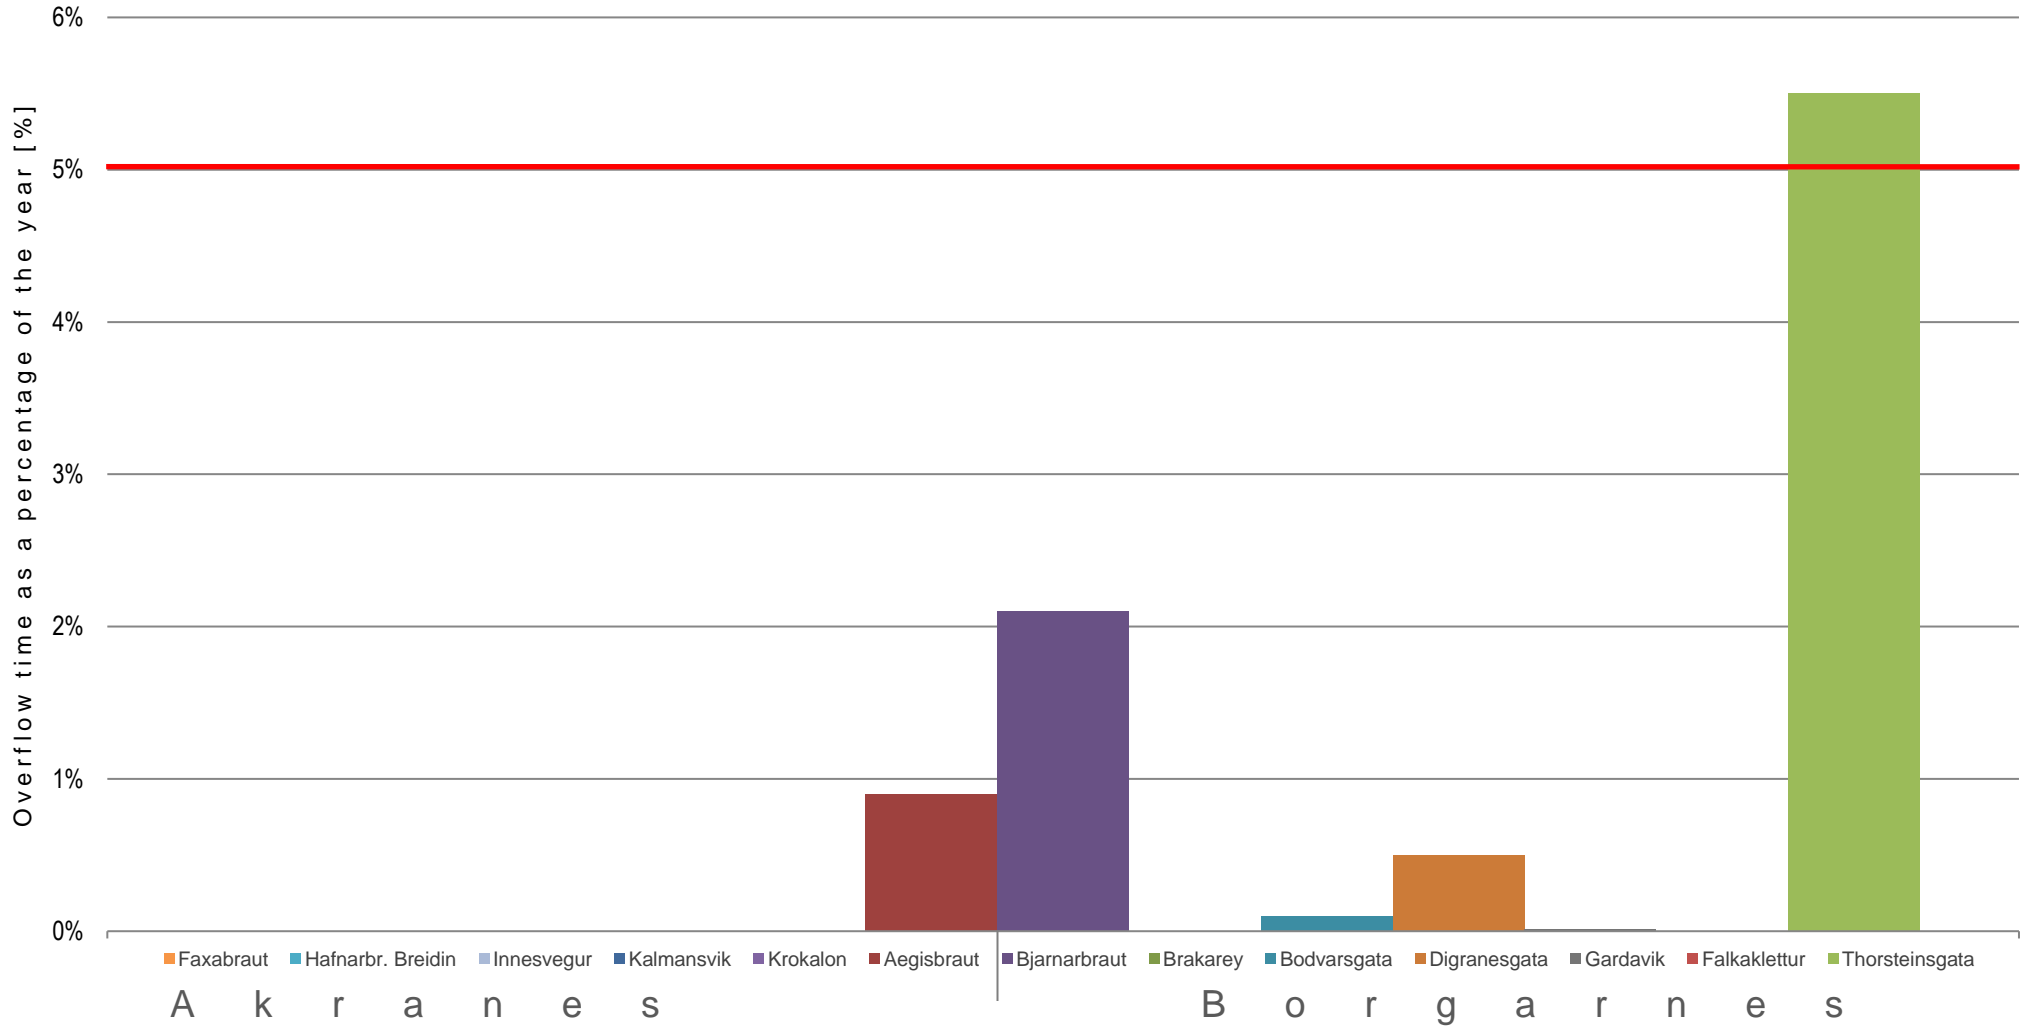
## Release via overflows in West Iceland 2021

In 2020, the discharge of wastewater via overflows in West Iceland was within Veitur Utilities' established limits, apart from Thorsteinsgata in Borgarnes. According to regulation no. 798/1999 on Sewerage systems and Sewage, overflow in the sewerage system may be active for up to 5% of the time of the year, or when the sewage mixed with hot water from district heating utilities or rainwater is at least on a ratio of 1:5.
